Manhole Inspection Summary

Manhole # S19II2056MH

Location Address: **5943 STANTON AVE**

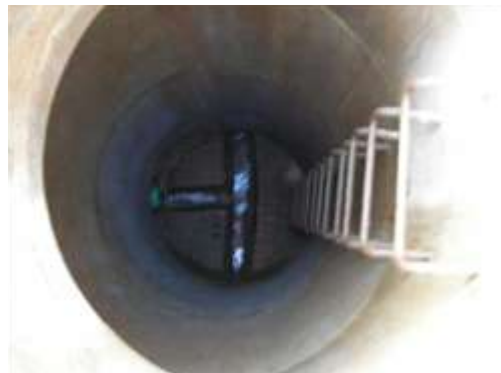
Top View

Bench debris.

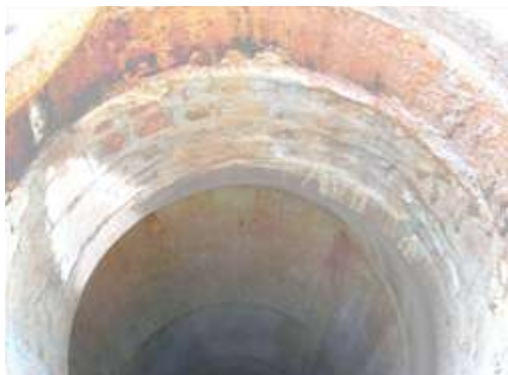
Defect

☒ **Leaks**

Condition: ☐ Sound ☐ Cracked ☐ Root Intrusion ☐ Loose Brick ☒ **Deteriorated**

Infiltration: ☐ None ☒ **Joint** ☐ Cracks ☒ **Mortar** ☐ Roots ☐ Wall

Frame leaks. Adjustment deterioration and infiltration. Corbel and Barrel infiltration.

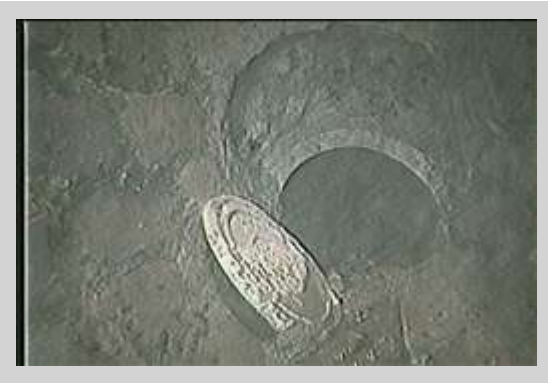
Pipe Out @ 12 O'Clock

Deposits: ☐ None ☒ **Mud** ☐ Sludge ☒ **Debris** ☐ Grease

Silt Depth: **1** (in.) Deposits Extent: **Light**

Infiltration: **Evidence** Pipe Seal Cond: **Unknown**

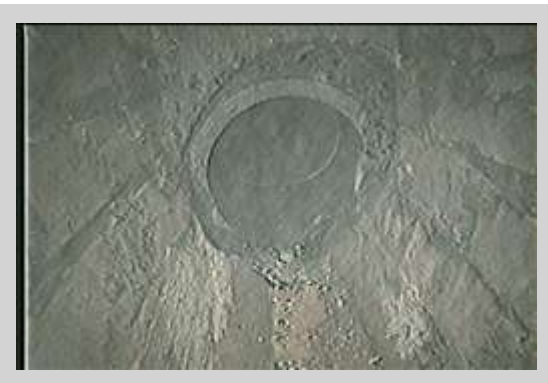
Pipe In @ 6 O'Clock

Infiltration: **Evidence** Pipe Seal Cond: **Unknown**

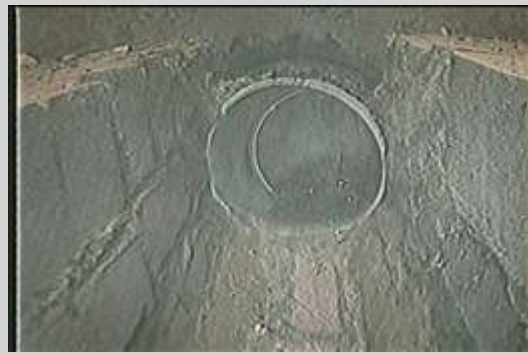
Drop In @ 9 O'Clock

Channel deterioration.
